About Lowland Rivers in Tokyo

→ Rivers in eastern lowlands of Tokyo

Main Four Projects of Lowland Rivers

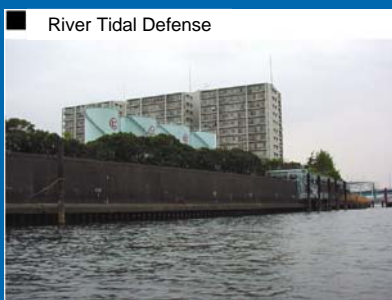
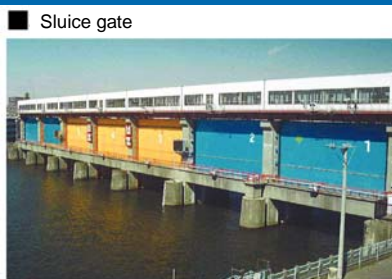
Storm surge Control facility improvement Project

Storm surge measures are almost completed

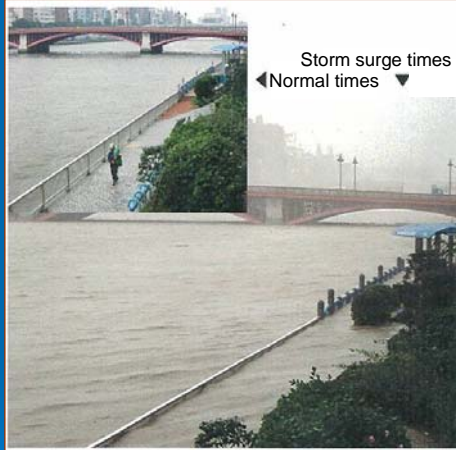
Effect of Storm surge Control facility improvement

On September 11, 2001, Typhoon No. 15—the largest class typhoon of the postwar era—comes ashore at Tokyo. The tide level at that time was A.P. + 3.15 m, roughly the same tide level as experienced in the August 1949 Kitty Typhoon, when 122 persons died or were injured. However, in Typhoon No. 15, due to the near completion of tide embankments, etc., along main rivers, there was no damage resulting from the high tides of rivers.

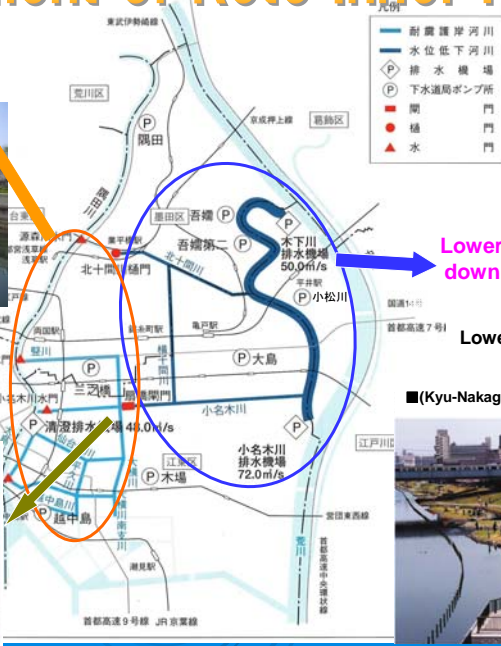
"Anti-seismic revetment method" is being carried out on the western side

Establish lock to allow boats to pass

Lower the water level down on the eastern side

Lower the water level to A.P.-1.0m

■ (Kyu-Nakagawa River)

Improvement of Koto Inner Rivers

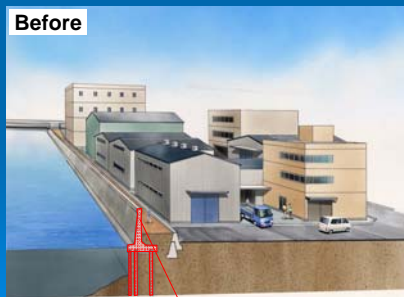
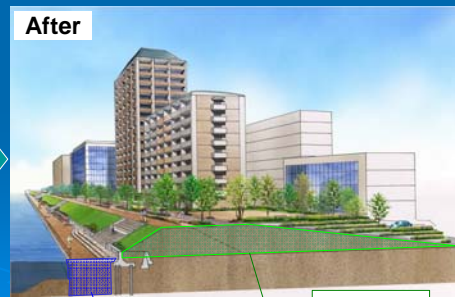
Improvement of Super Levees

○Two Aims

Earthquake Resistance and
Improvement of Water Accessibility

○Implemented in cooperation with local
development along the riverside

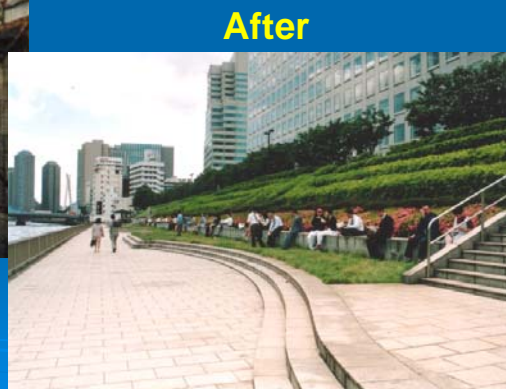
Case Example of Improvement of Super Levee (Sumida River) (Hakozaki Area)

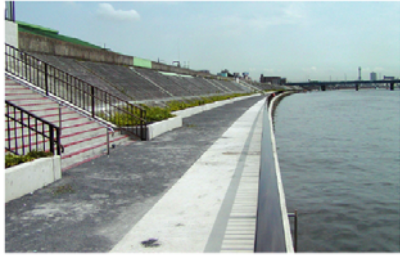
Levee (photo: Nakagawa River)

Earthquake-resistance measures for river facilities

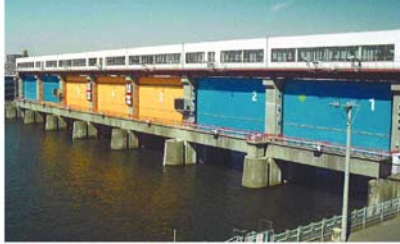
Sluice gate/ Drainage pumping station (photo: Imai sluice gate)

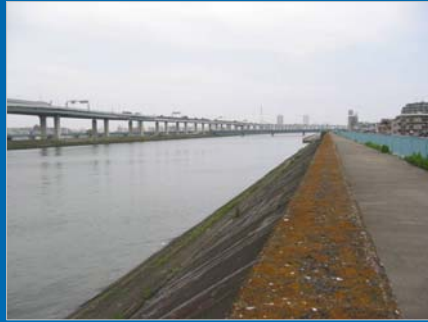
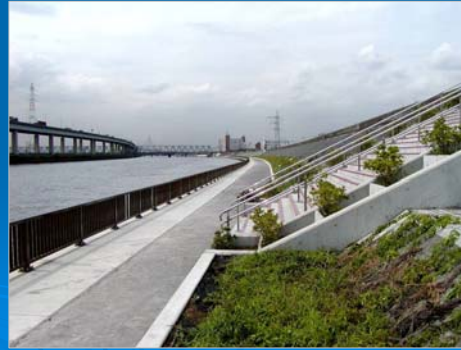
Case Example of Improvement of Nakagawa River (Before/ After)

Before

After
