Typhoon Kathleen (1947) Severe rainfall (2005) Typhoon Kitty (1949) Severe rainfall 12.5 mm Total rainfall 12.7 mm Inundation below floor level 45, 167 homes 1. Overview of Tokyo: Major floodings O'Tokyo has suffered damage from Typhoons, severe downpours, and storm surges innumerable times O'While river development is making headway, downpours exceeding design standards have increased in recent years and flooding occurs almost annually Storm surge damage Typhoon Kitty (1949) Typhoon Kitty (1949) Tide level A. P+3. 15 Flood area 9.2 km² Inundation below floor level 3,374 homes Inundation below floor level 64,127 homes 1 mundation below floor level 64,127 homes 3

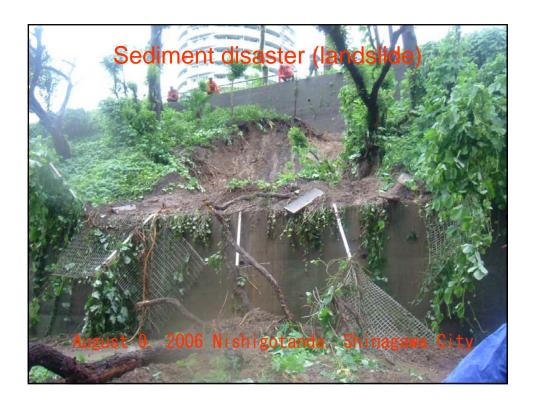
4. Evacuation system and information distribution: Potential sediment disaster areas

Dangerous areas: Approx. 3,700 locations

Potential avalanche streams

Approx. 700

Potential steep-slope collapse areas

Approx. 3,000

Potential landslide areas Approx. 40

After completing a detailed investigation

The estimate rose to around 8,000 locations
